**FINAL INVESTIGATION REPORT ON ACCIDENT TO M/S CHIMES
AVIATION ACADEMY PVT LTD. CESSNA-172 VT-CAI IN BARGI DAM,
JABALPUR ON 06.04.2009.**

1. Aircraft	Type	Cessna-172
	Nationality	Indian
	Registration	VT-CAI
2 Owner/Operator		Chimes Aviation Academy Pvt. Ltd
3 Pilot – in –Command		Student Pilot
	SPL No	CAA/D/133
	Extent of injuries	Fatal
4 Co-Pilot		N/A
	CPL No	N/A
	Extent of injuries	N/A
5 No. of Passengers on board		Nil
	Extent of Injuries	N/A
6 Last point of Departure		Dhana Airstrip
7 Intended landing place		Dhana Airstrip
8 Type of operation		Solo Cross-country flight
9 Place of Accident		Bargi Dam, Jabalpur 22deg 50’N 79deg 58’E
10 Date & Time of Accident		06/04/2009; 1100 UTC Approx

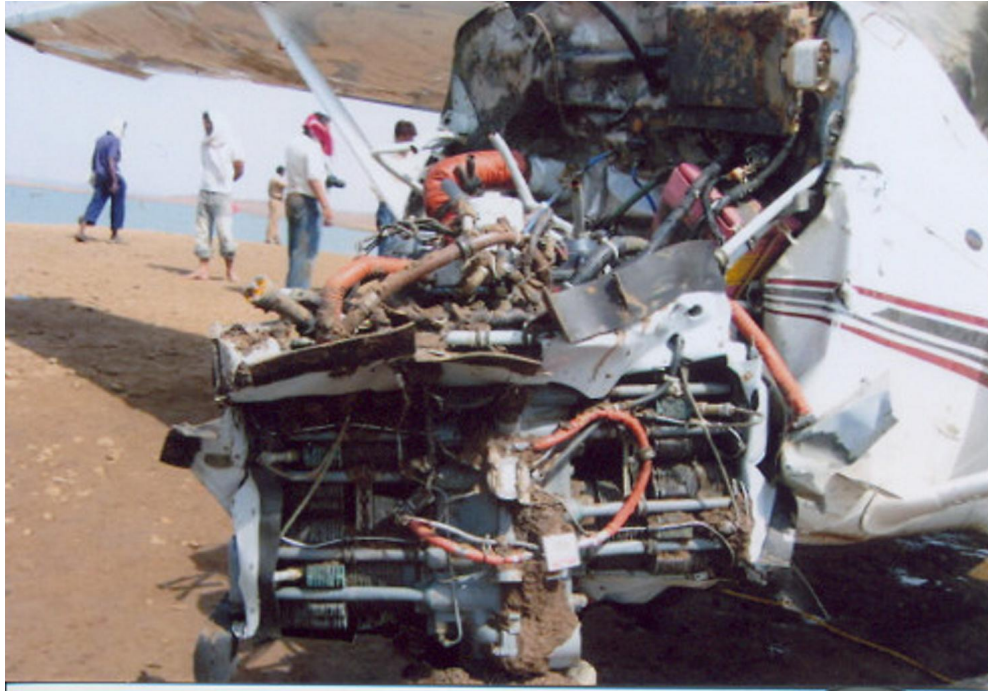
COMPLETELY DAMAGED AIRFRAME AND ENGINE

The aircraft observed to have received impact while coming in contact with water. Following damage was observed as follows –

- The engine mount was broken and engine was tilted down.
- The propeller blades were found twisted & bend.
- The Nose landing gear was missing.
- Engine cowlings were missing & firewall yielded inward to cabin.
- There was distinct black soot deposit on the top half portion of the firewall.
- Lower instrument panel found buckled with engine controls intact. The position of throttle was full in and mixture was one inch out to lean position.
- Centre console found distorted with parking brake assembly broken. The Fuel Selector Valve (FSV) was found selected in BOTH position.
- The flap motor position was checked to identify the position of the flap and was found in retracted position.
- Seat head rest found bend.
- There was no post impact fire as the aircraft went in the water body.

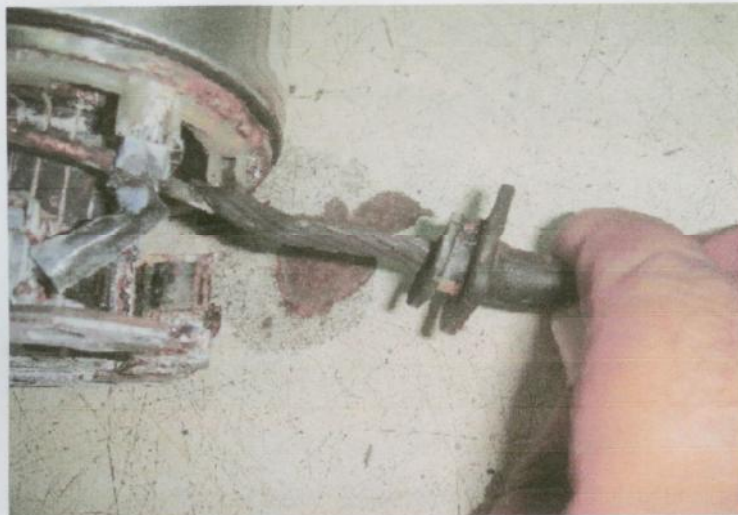
The Starter operational check without load was carried out at 24 VDC the solenoid operated and pushed the meshing gear forward however it did not start even at 19 Amp. The unit was jammed and not rotating with hand. The burnt marks observed on the cable at positive terminal. Brush assembly cover is opened and the brush holders and brush assembly found overheated and burnt. The carbon deposit was not found indicating that the armature was in standstill condition and not rotating. Condition of brushes found in good condition.
